PRELIMINARY STORMWATER SITE PLAN

Preliminary Plat of Tolt River Terrace

3660 Tolt Avenue
Carnation, WA 98014

May 23, 2019

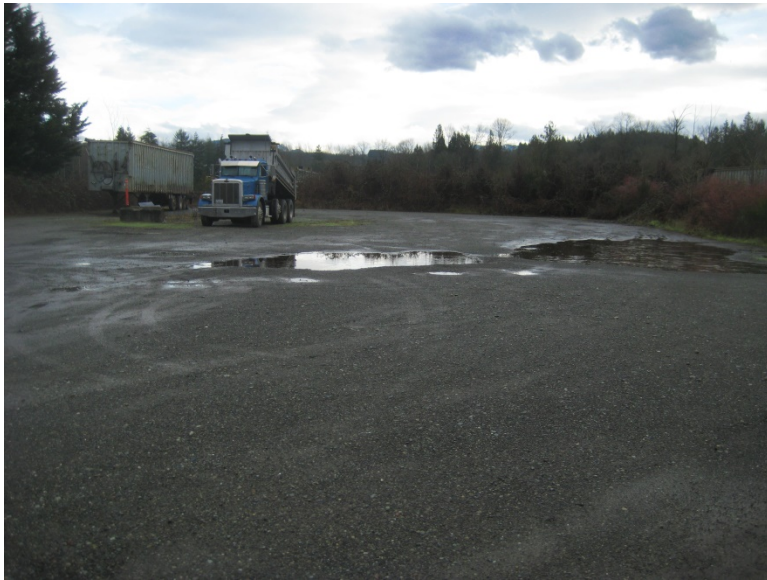
Date of Photo:	1-20-17
Location:	Western entry to subject site looking east.
Description:	The site has been cleared and graded. The topography is flat with several puddles collecting surface water across the site.

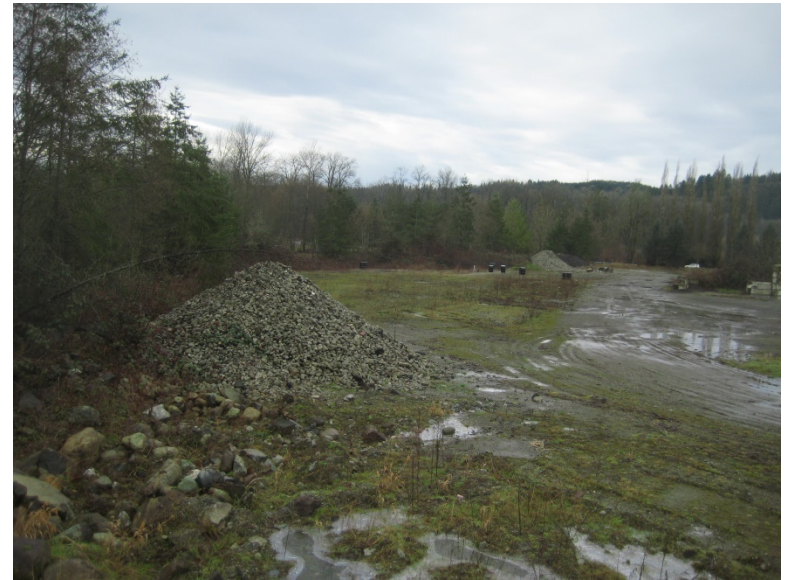
▼ Photo Number 2

Date of Photo:	1-20-17
Location:	South central portion of subject site looking west.
Description:	The site generally drains from east to southwest, mostly by sheet flow.

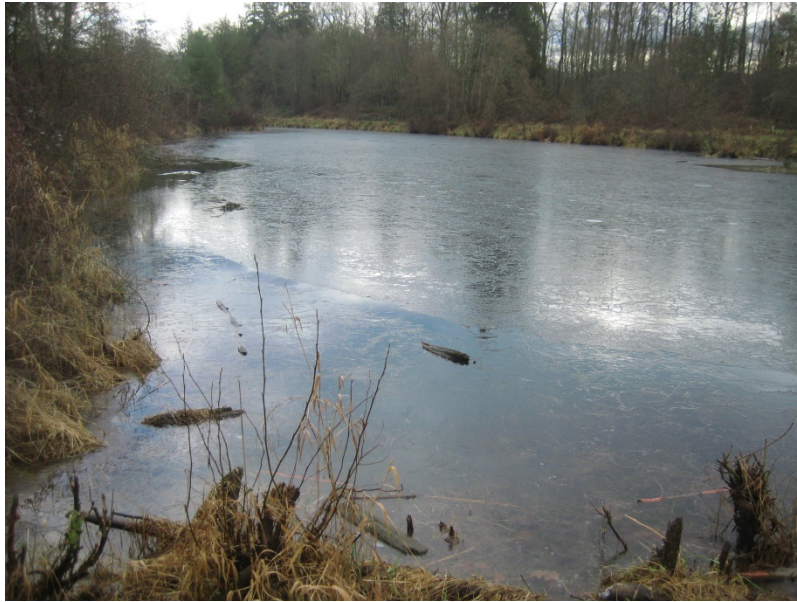
▼ Photo Number 3

Date of Photo:	1-20-17
Location:	Location 5 in Figure 4 looking east
Description:	Two ponds are located along the southern portion of the site.

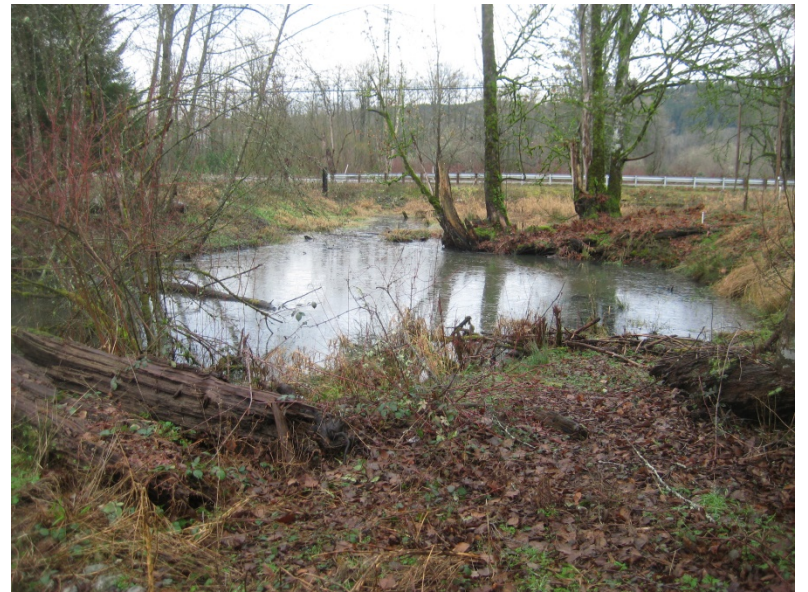
▼ Photo Number 4

Date of Photo:	1-20-17
Location:	Location 5 in Figure 4 looking west.
Description:	A berm separates the site's westerly pond from the site's discharge location that flows to a culvert under SR 203.

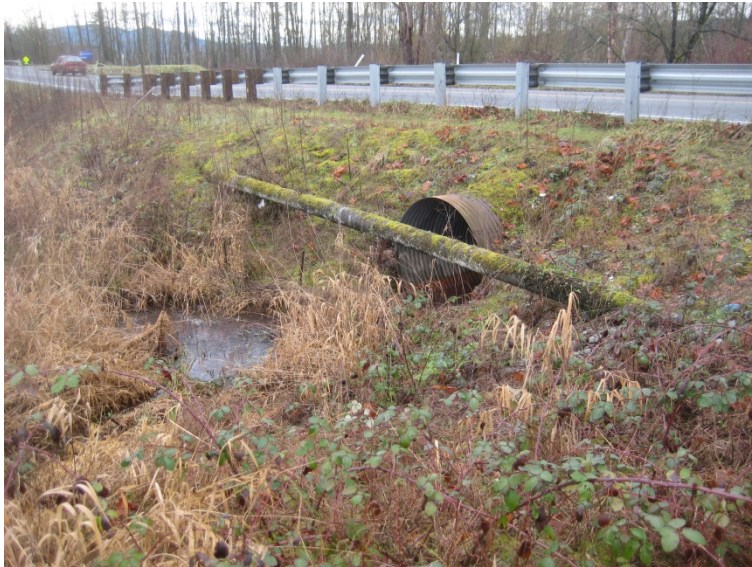
▼ Photo Number 5

Date of Photo:	1-20-17
Location:	Location 7 in Figure 4 looking downstream.
Description:	A 60-inch diameter culvert conveys flows under SR 203.

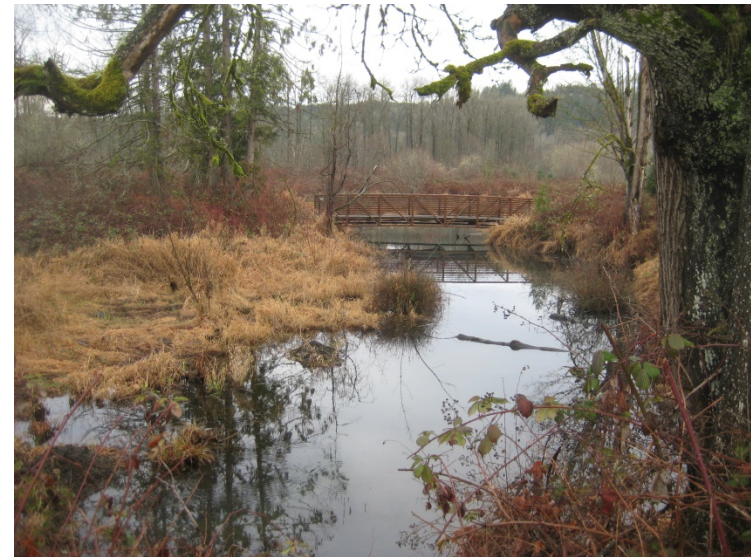
▼ Photo Number 6

Date of Photo:	1-20-17
Location:	Location 8 in Figure 4 looking downstream.
Description:	The channel significantly widens once crossing to the west side of SR-203.

Runoff collected in the roadside ditch along SR 203 and outflow from the ponds collects in a ponded wetland area (Location 5; Photos 4) before flowing to a 60-inch diameter CMP that crosses under SR 203 (Location 7; Photo 5). On the west side of SR 203, the channel/wetland (Location 8; Photo 6) expands in width and flows under a pedestrian bridge before further widening into a broad open

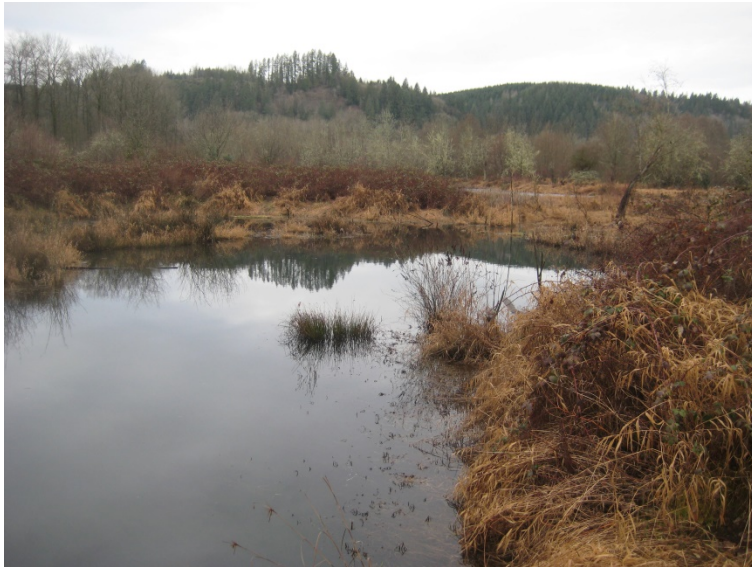
Date of Photo:	1-20-17
Location:	Location 9 in Figure 4 looking downstream.
Description:	The open water component of the channel/wetland system further widens beyond the pedestrian bridge.

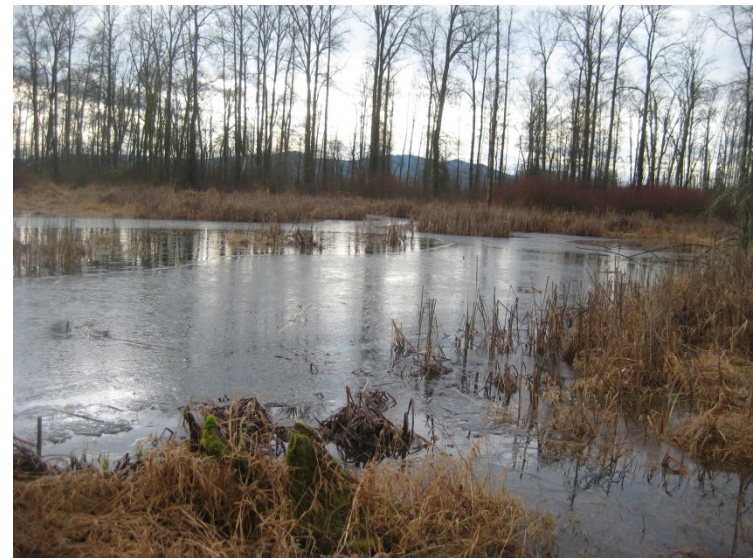
▼ Photo Number 8

Date of Photo:	1-20-17
Location:	Location 10 in Figure 4 looking south.
Description:	The wetland system hydrology is directly affected by the Snoqualmie River.

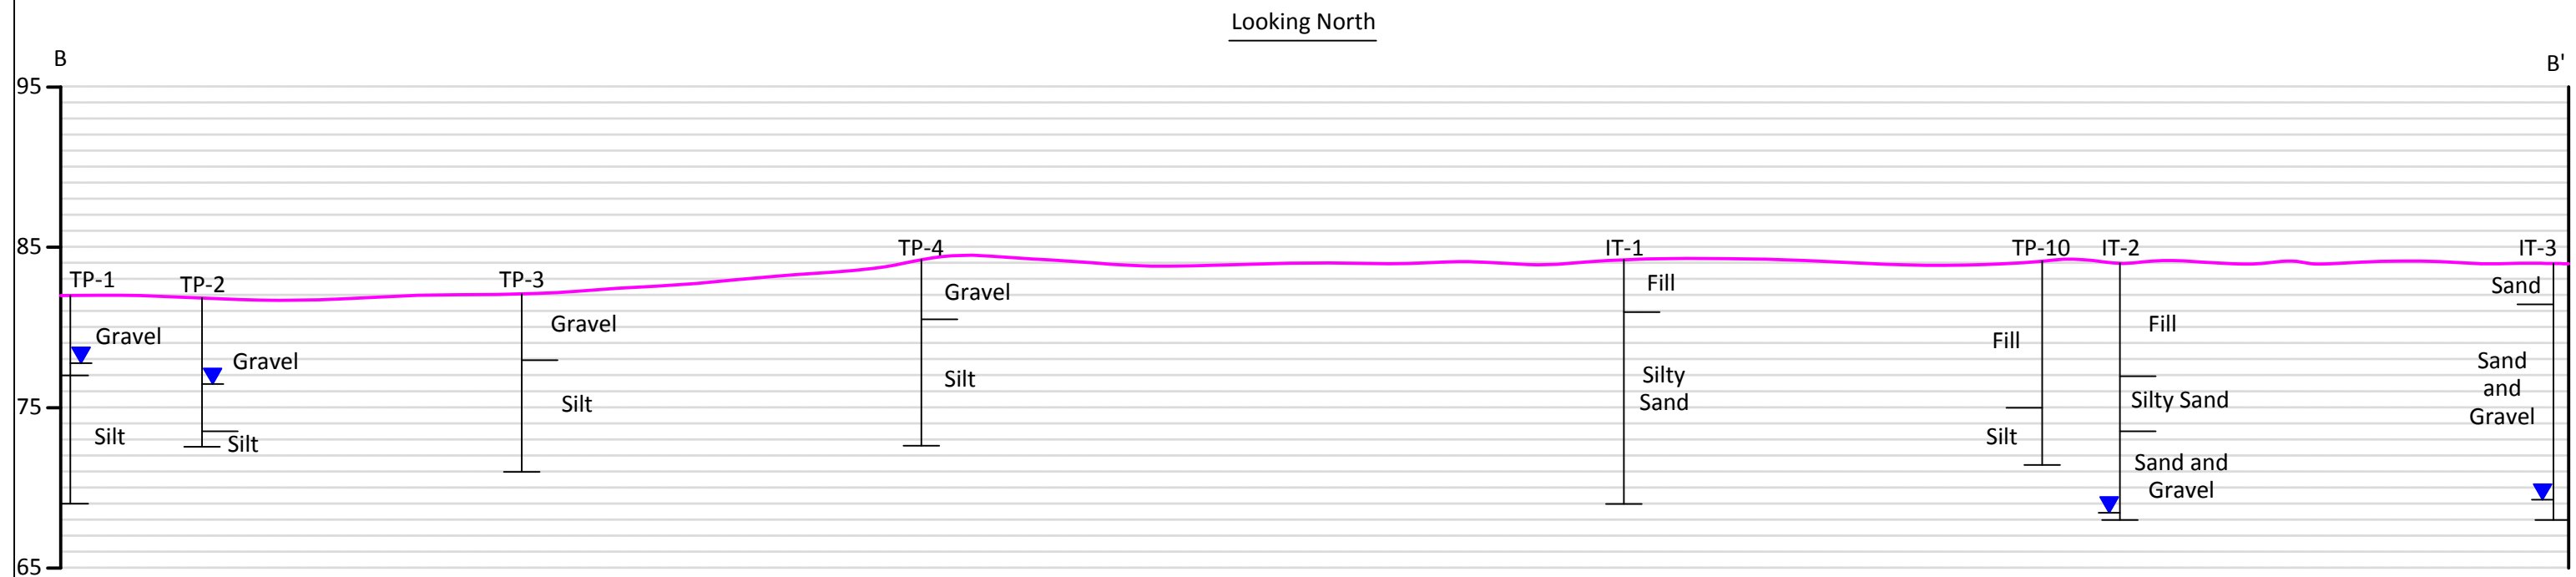
▼ = Groundwater encountered
